**SUSQUEHANNA RIVER BASIN**  
**BROAD CREEK, HARFORD COUNTY**  
**MARYLAND**

# **BROAD CREEK DAM**

**NDI NO. MD 00017**

## **PHASE I INSPECTION REPORT**

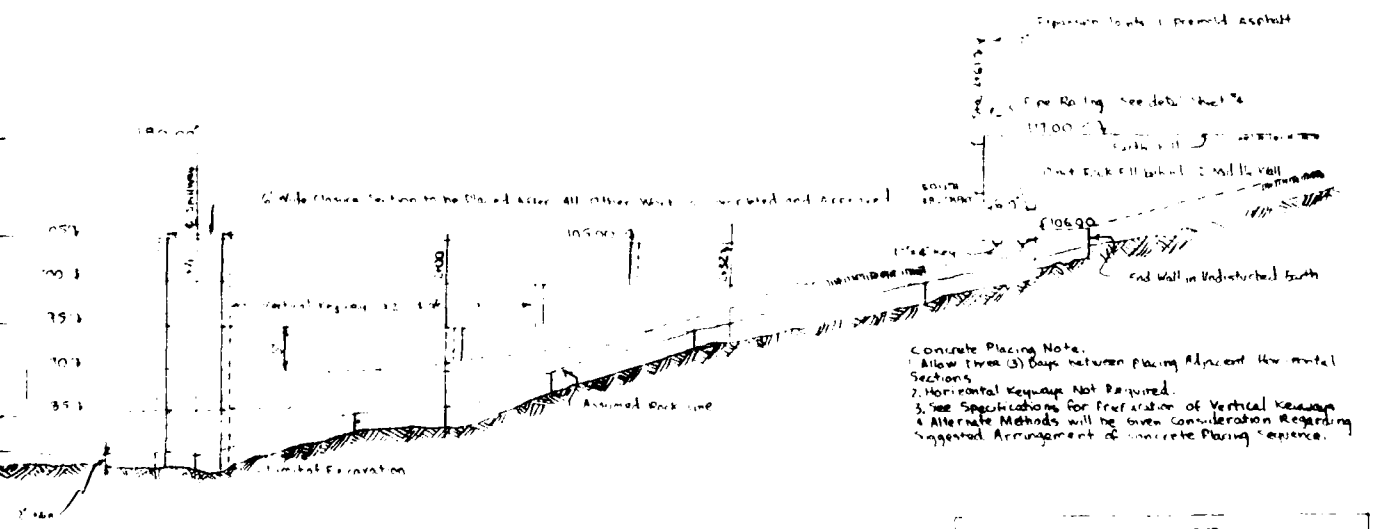
BOY SCOUTS OF AMERICA  
BALTIMORE AREA COUNCIL  
BOY SCOUT DAM ON BROAD CREEK  
PLAN AND LONGITUDINAL SECTIONS  
WATMAN, REQUARDT AND ASSOCIATES JULY 1947  
CONSULTING ENGINEERS  
SHEET 3 OF 7

2.2 Construction. The only construction data available is contained on a design plan and profile drawing, Sheet 3 of 7, marked in red pencil indicating the limits and dates of concrete pours and the foundation rock profile encountered.
